FEM PARAMETERS – RIVER SAVA

AFPO4

100-year return period

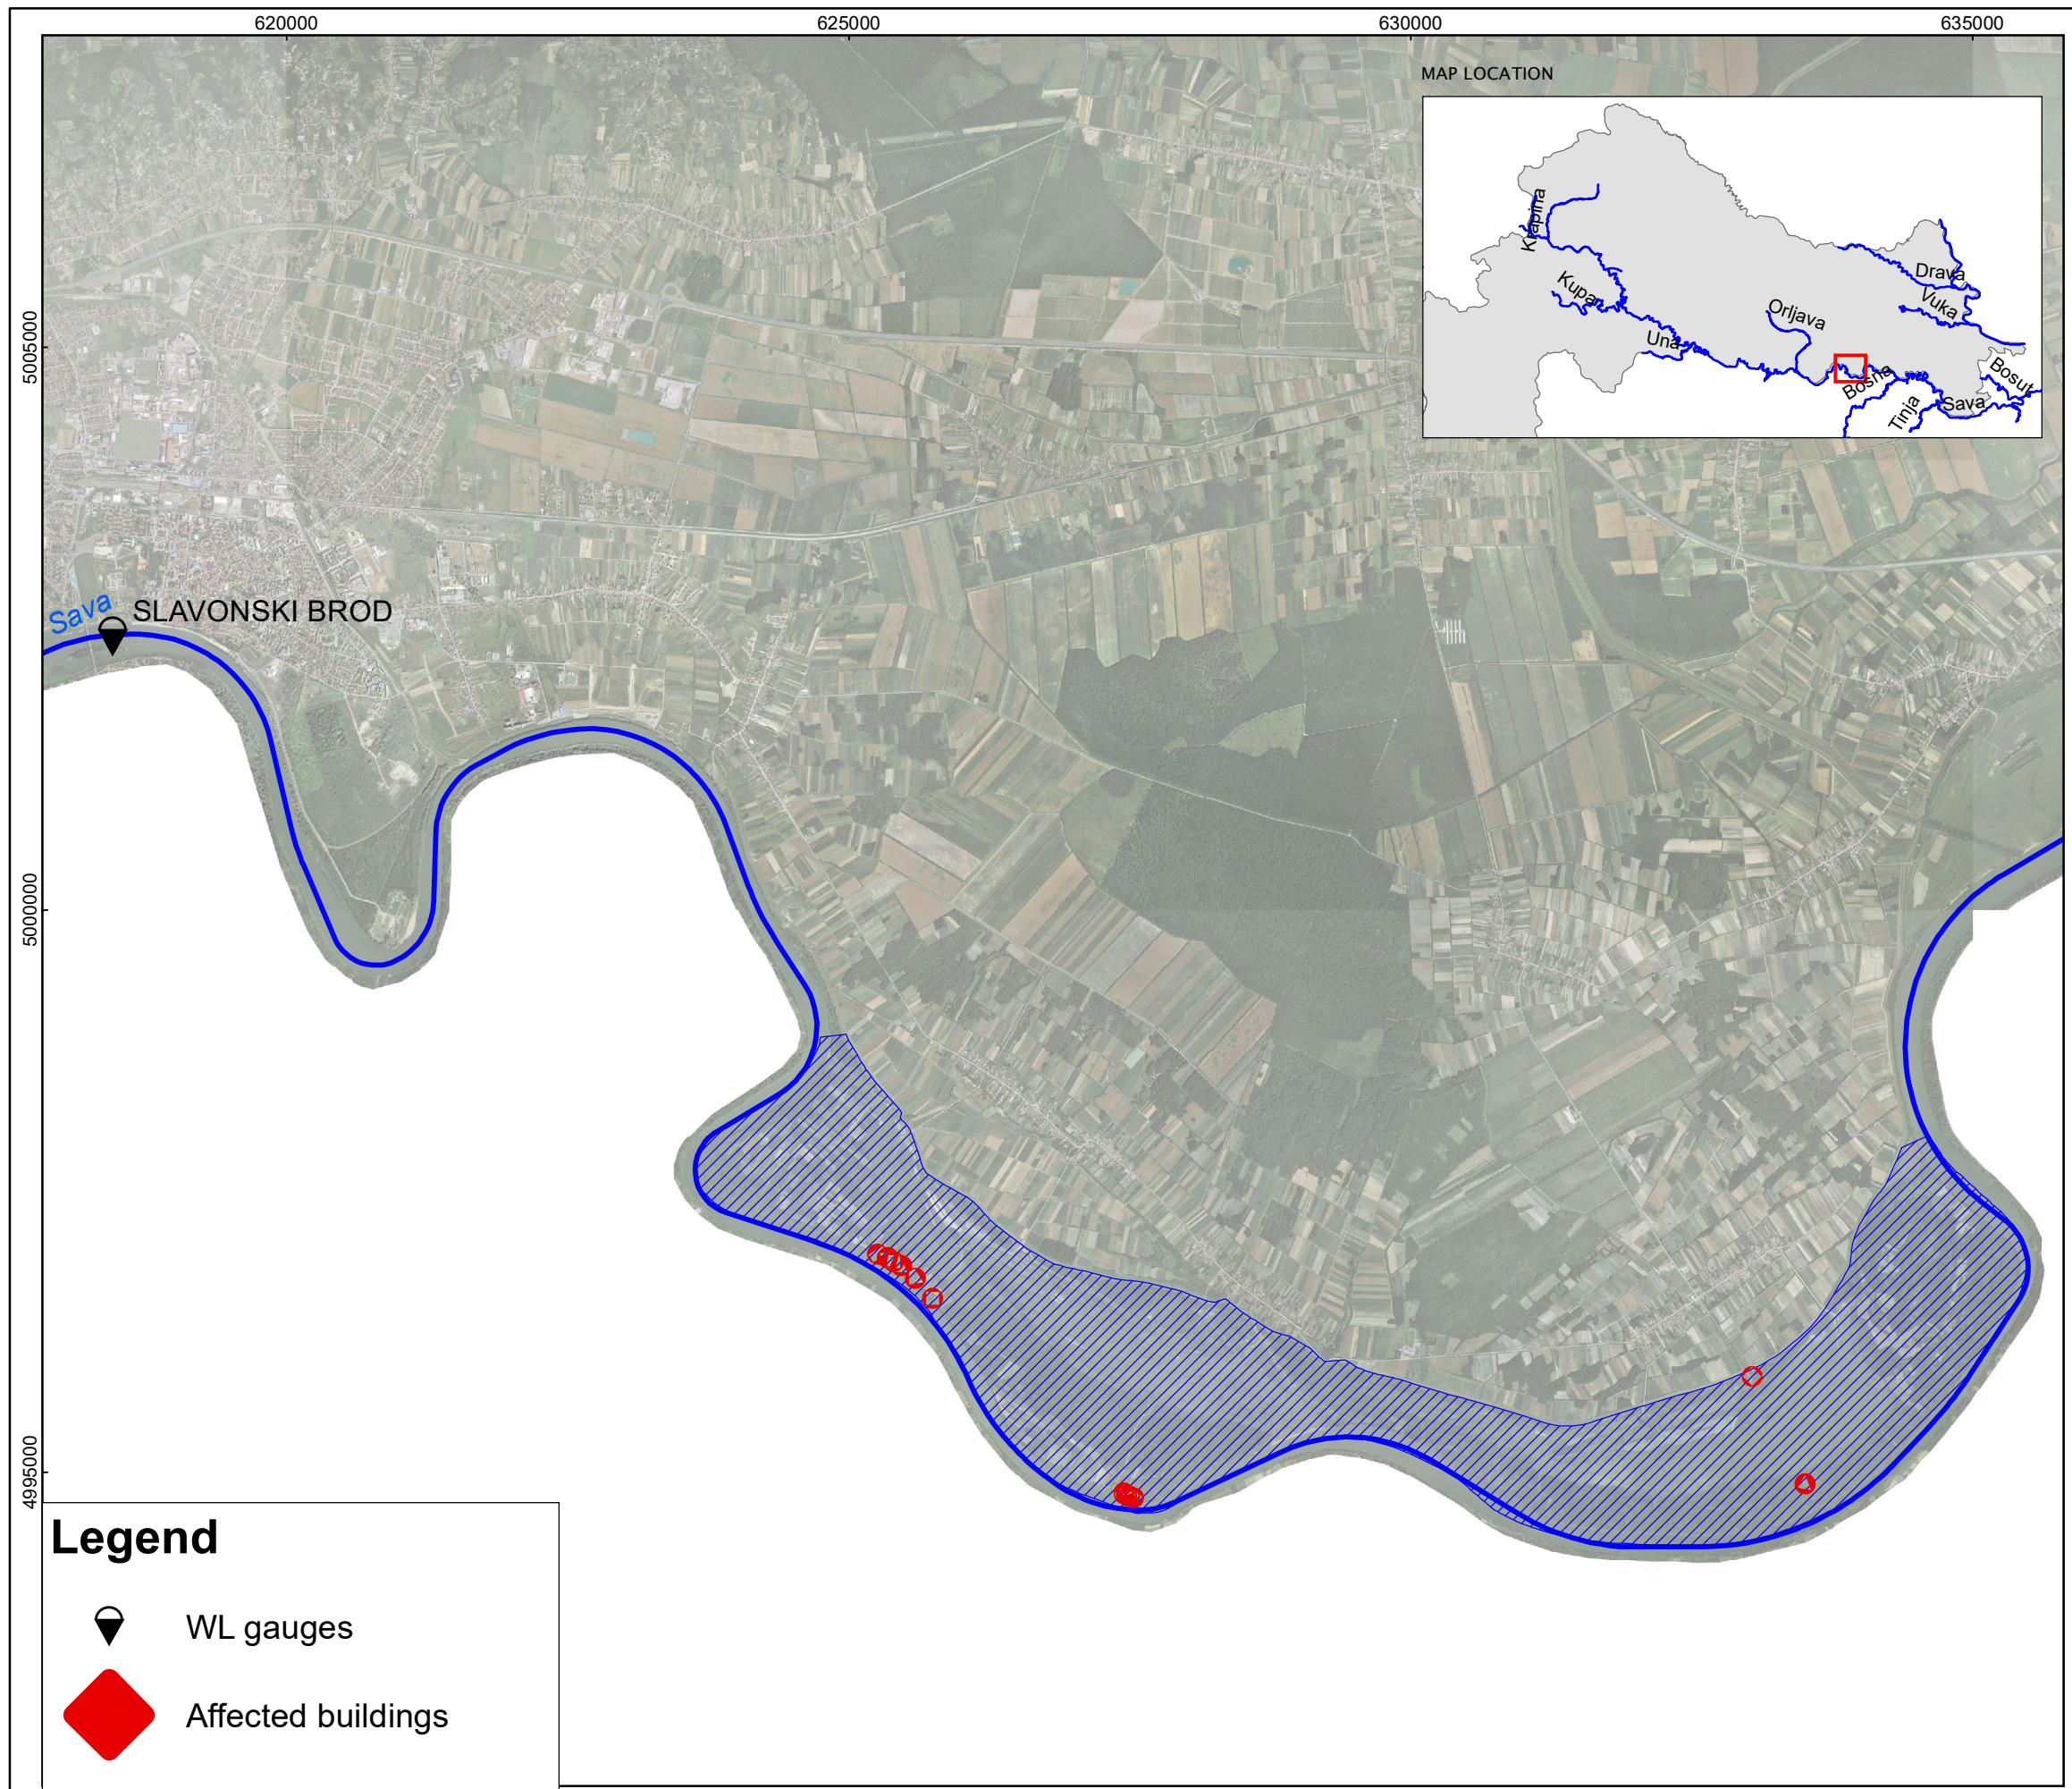
- Design flows $Q_{100} = 3433 \text{ [m}^3/\text{s]}$
 $Q_{\text{bankfull}} = 2494 \text{ [m}^3/\text{s]}$
- Peak reduction

$\Delta Q \text{ [m}^3/\text{s]}$	$\Delta Q_{\text{rel}} \text{ [%]}$	FEM Class
12.16	1.29	3

Flood wave translation $\Delta t \text{ [h]}$	FEM Class
4.00	3

$\Delta h \text{ [m]}$	FEM Class
0.10	1
- Flow velocity

$\Delta v \text{ [m/s]}$	FEM Class
0.00	1
- Shear stress

$\Delta \tau \text{ [N/m}^2]$	FEM Class
0.05	1

Historic Water Bodies	FEM Class
4 - FP Exist, Disconnected $Q=3312\text{m}^3/\text{s} > Q_{\text{bankfull}}$	1
- Existence of protected species and habitats

Protected species	FEM Class
78 species	5

Protected habitats	FEM Class
100% habitats	5
- Ecological water status

Value	FEM Class
3.96	3
- Potentially affected buildings

No houses / km ²	FEM Class
0.71	5

RESTORATION PRIORITY High
